Spatial Distribution of Metals in Lake Bottom Sediment at a Pulp Mill Effluent Discharge Site, Pictou Co. NS

Baillie Holmes, Kirklyn Davidson, Dr. Ian Spooner

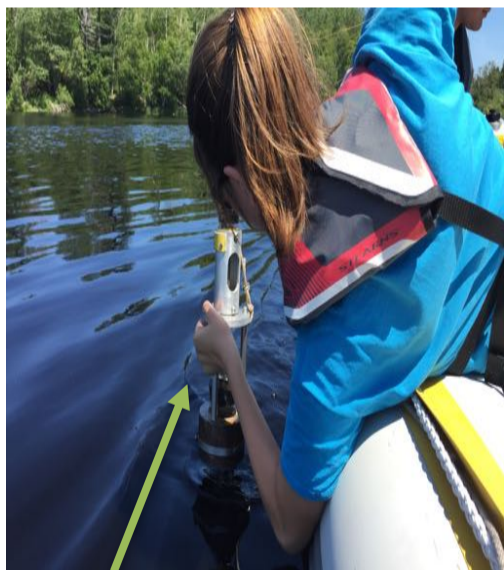
Cores were taken using a gravity coring device-

Then split in half and sampled

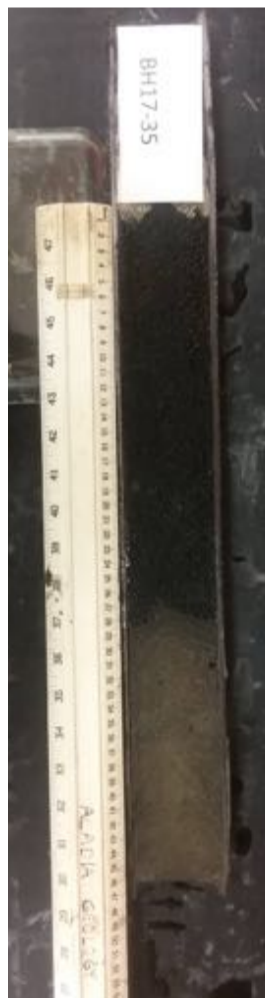
High organic post-mill sediment

Pre-mill marine silt
